To preserve the end point: The Meridian Statue

Gerd Johanne Valen. Site Manager Struve Geodetic Arc - Norway

Action plan and the WH Status.

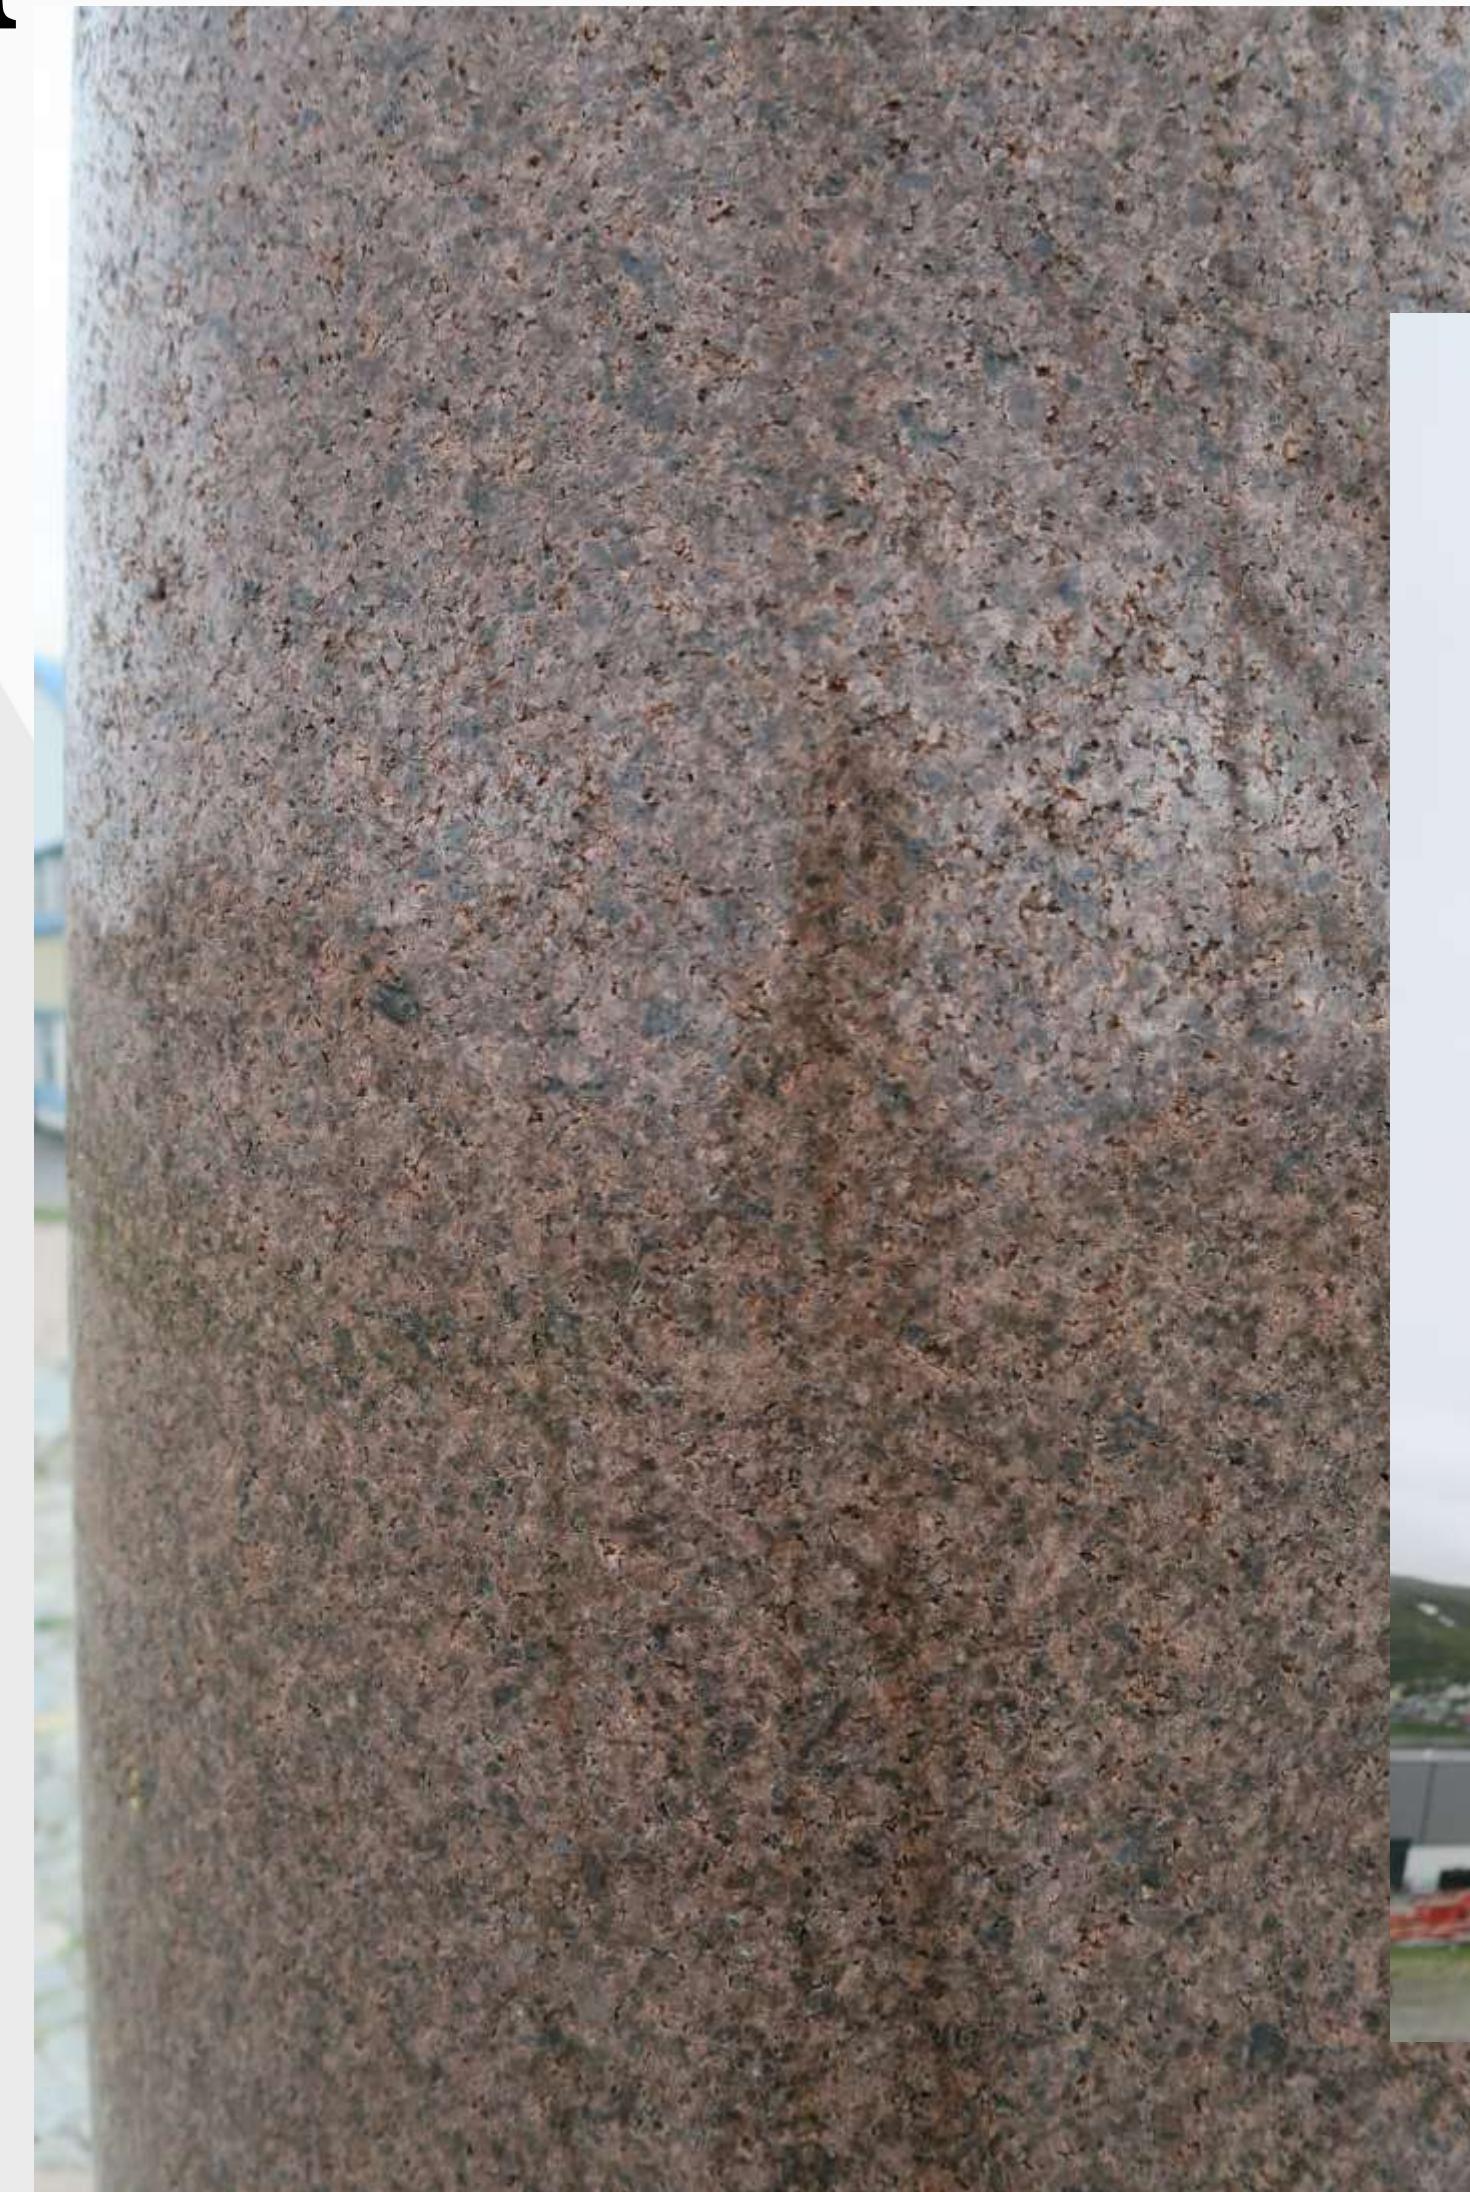
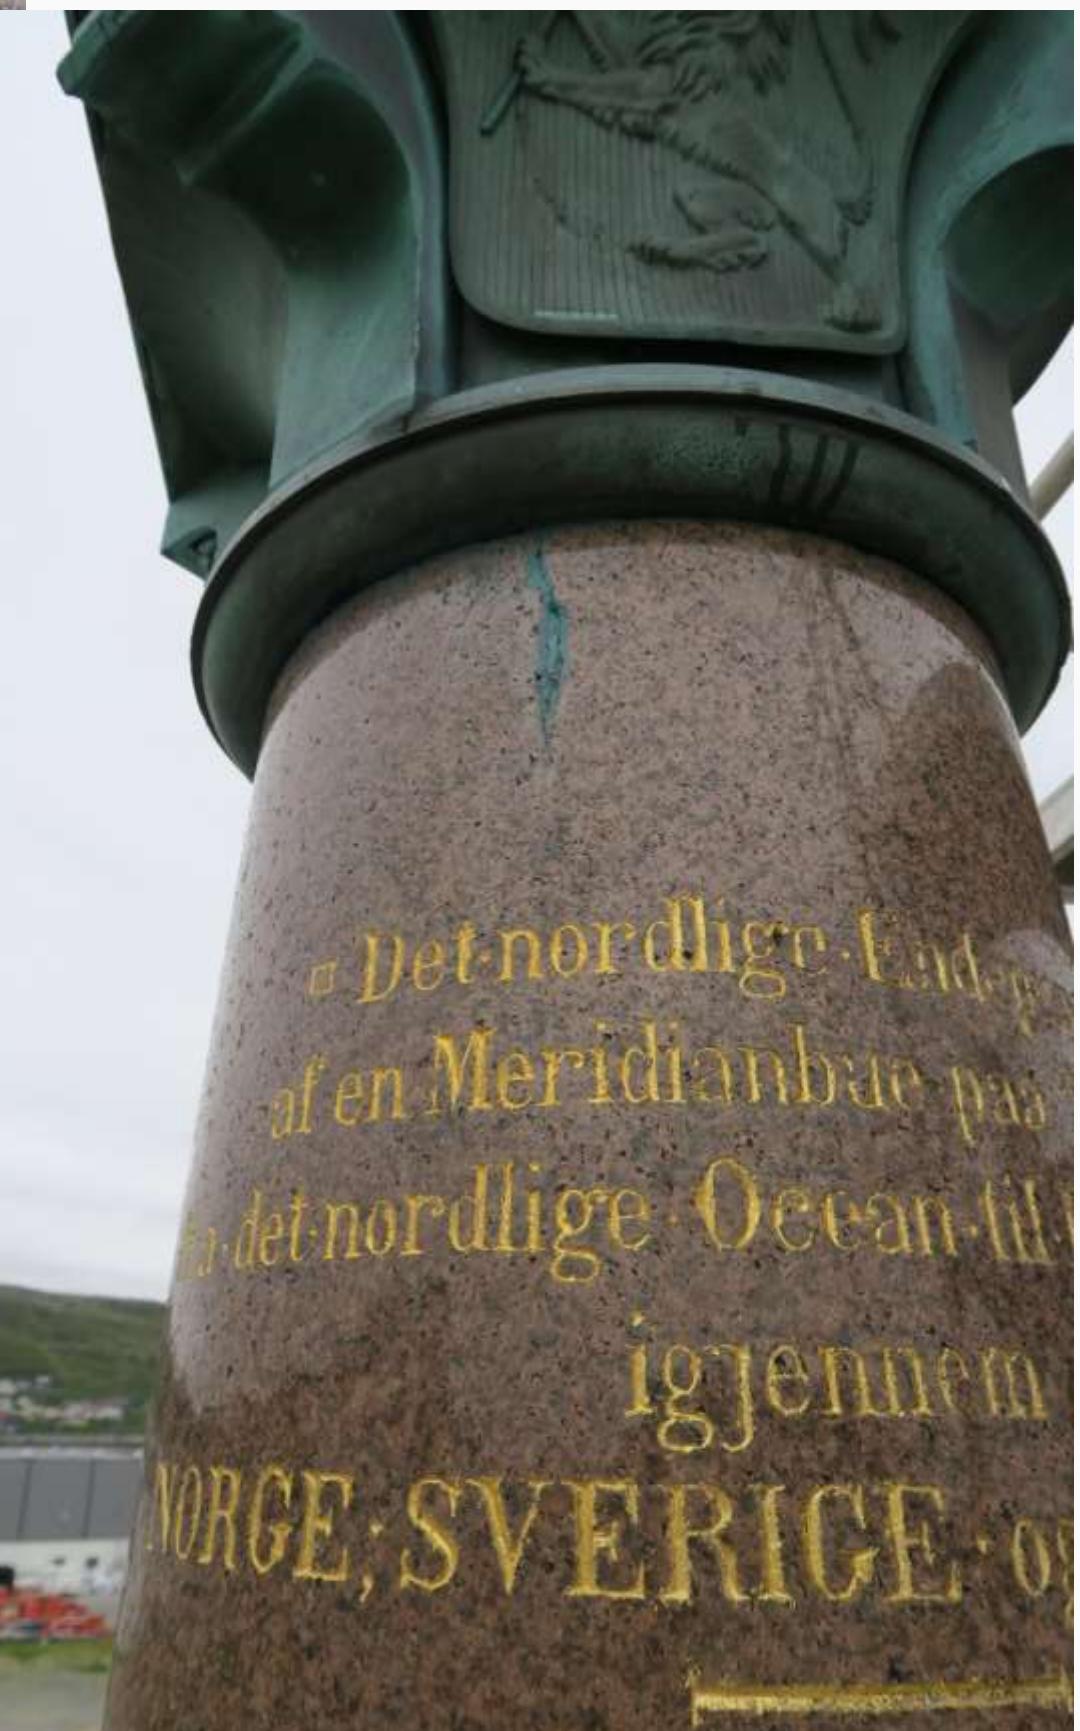
The Construction parts

The rock is extremely durable. But still it is effected by wind, rain and probably frost. From the North-West the weather condition is harsh. The engraved text must regular be renewed.

The construction or the method of joining the column with the capital is unknown. And there are tree weak points in the joints between the capital and the column. We do not know why.

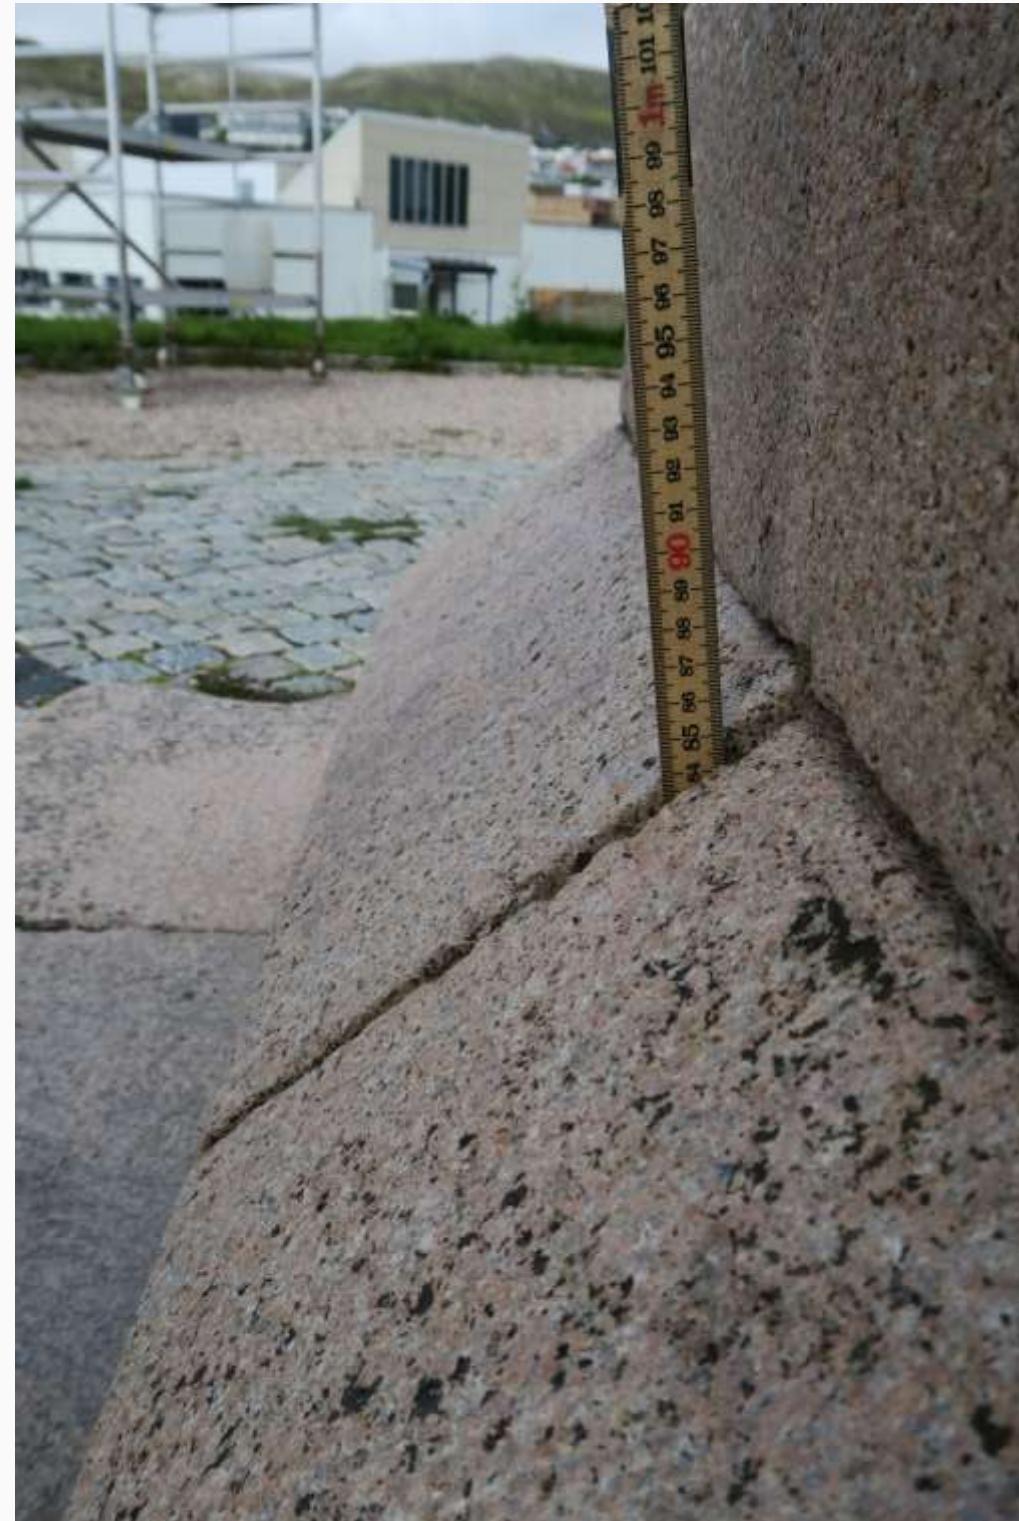
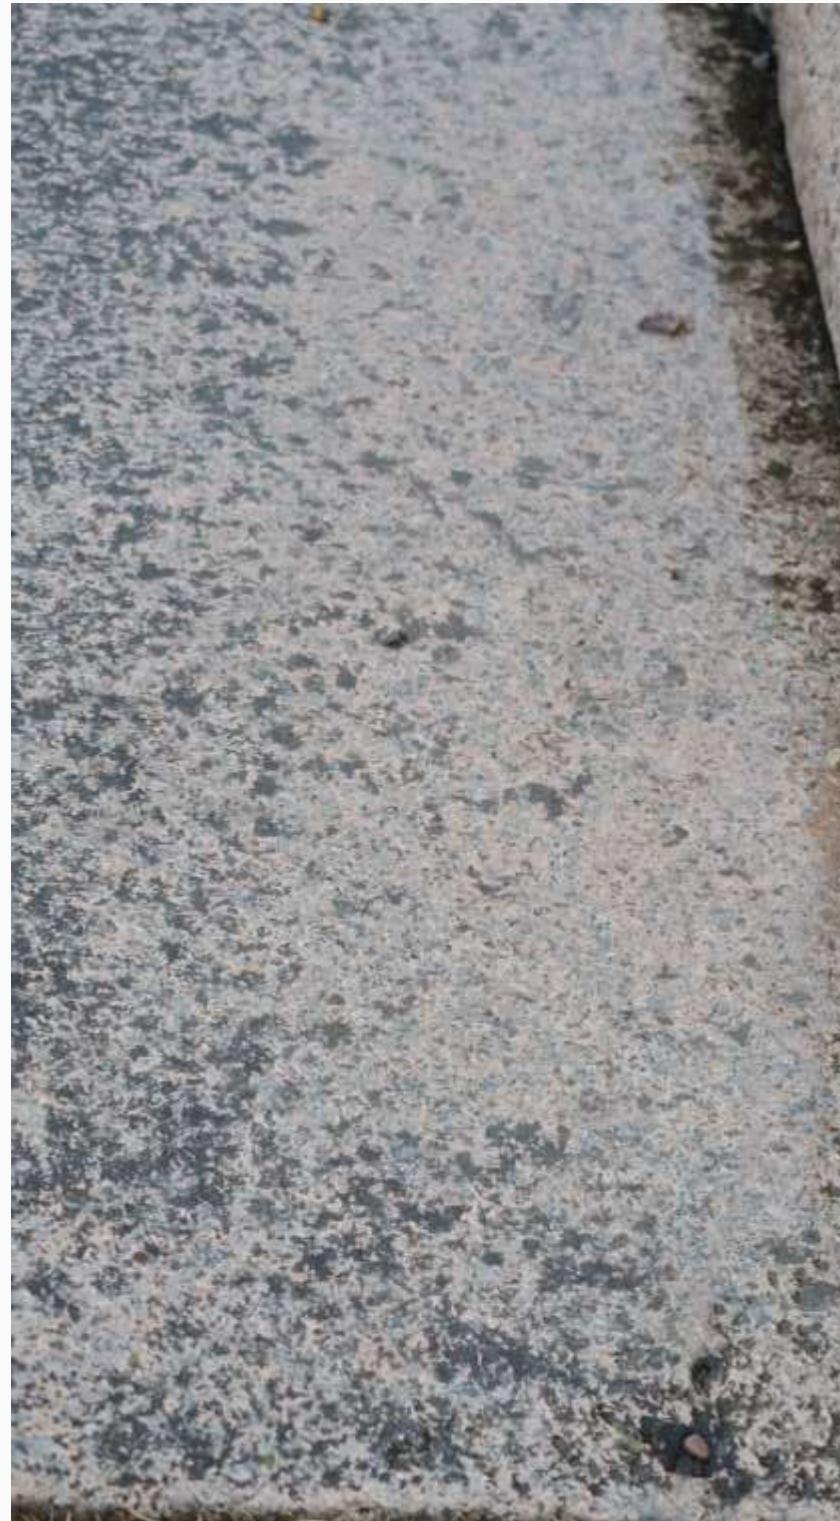
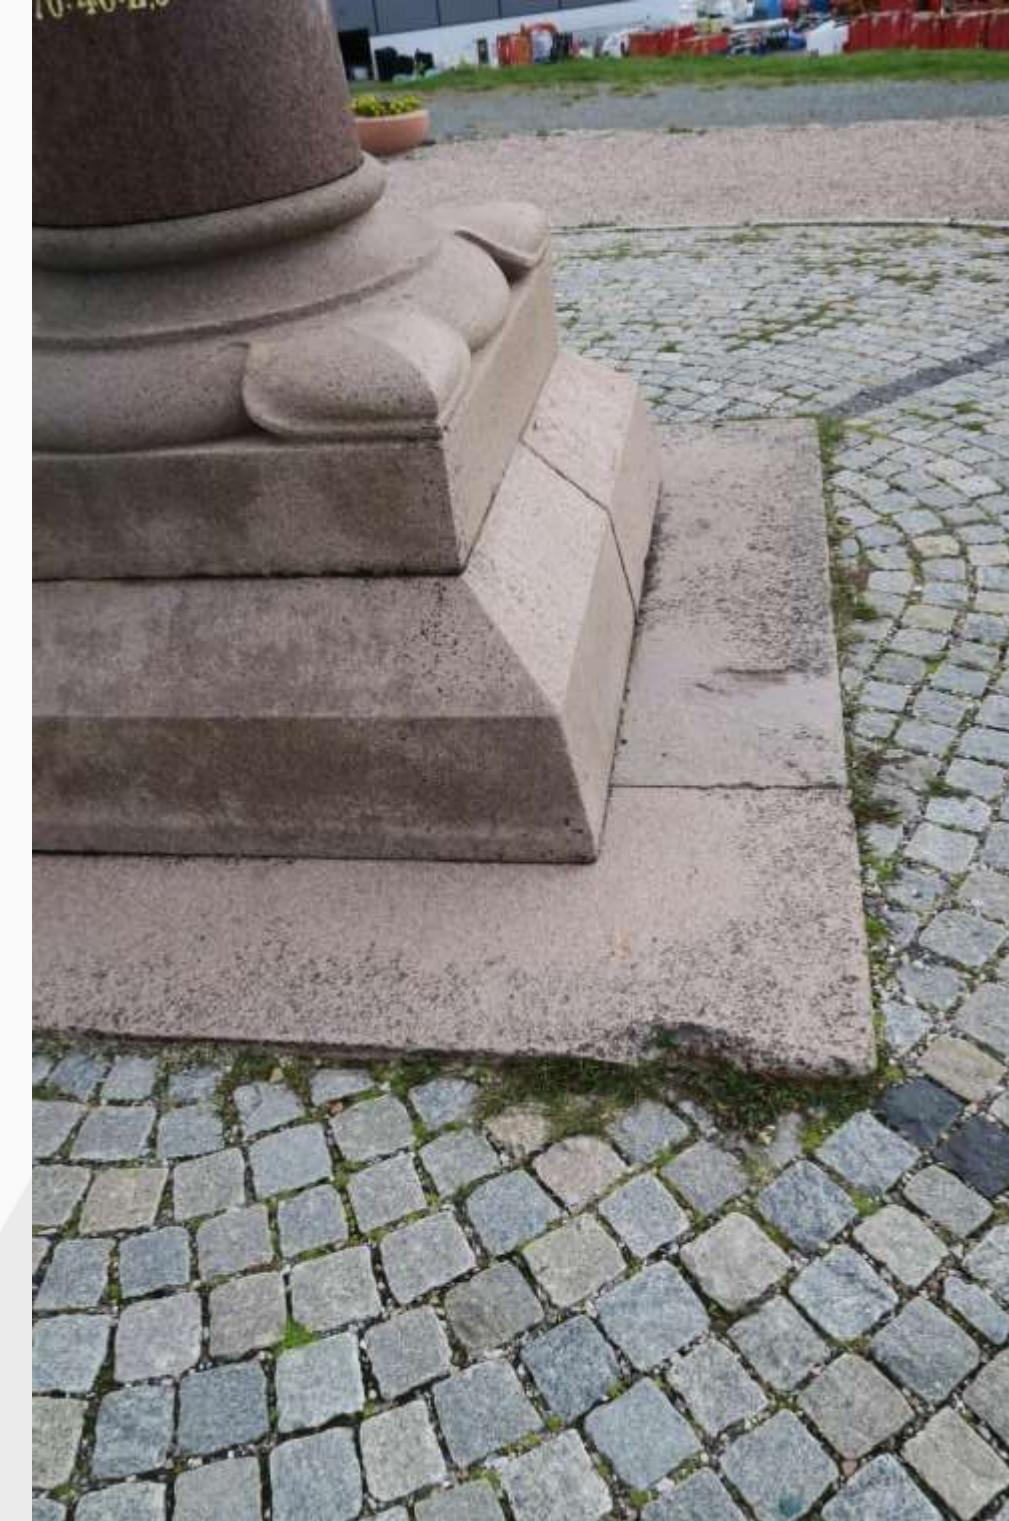
The plinth is of fine cut granite. Lichen and moss are present. Seabirds nesting nearby a problem this year. We have started to clean it with technical alcohol. The monument surrounded with rocks in 2006. This has made the monument 4 cm lower than original, and it is a risk for drainage of water, and ice and melting processes under the Statue.

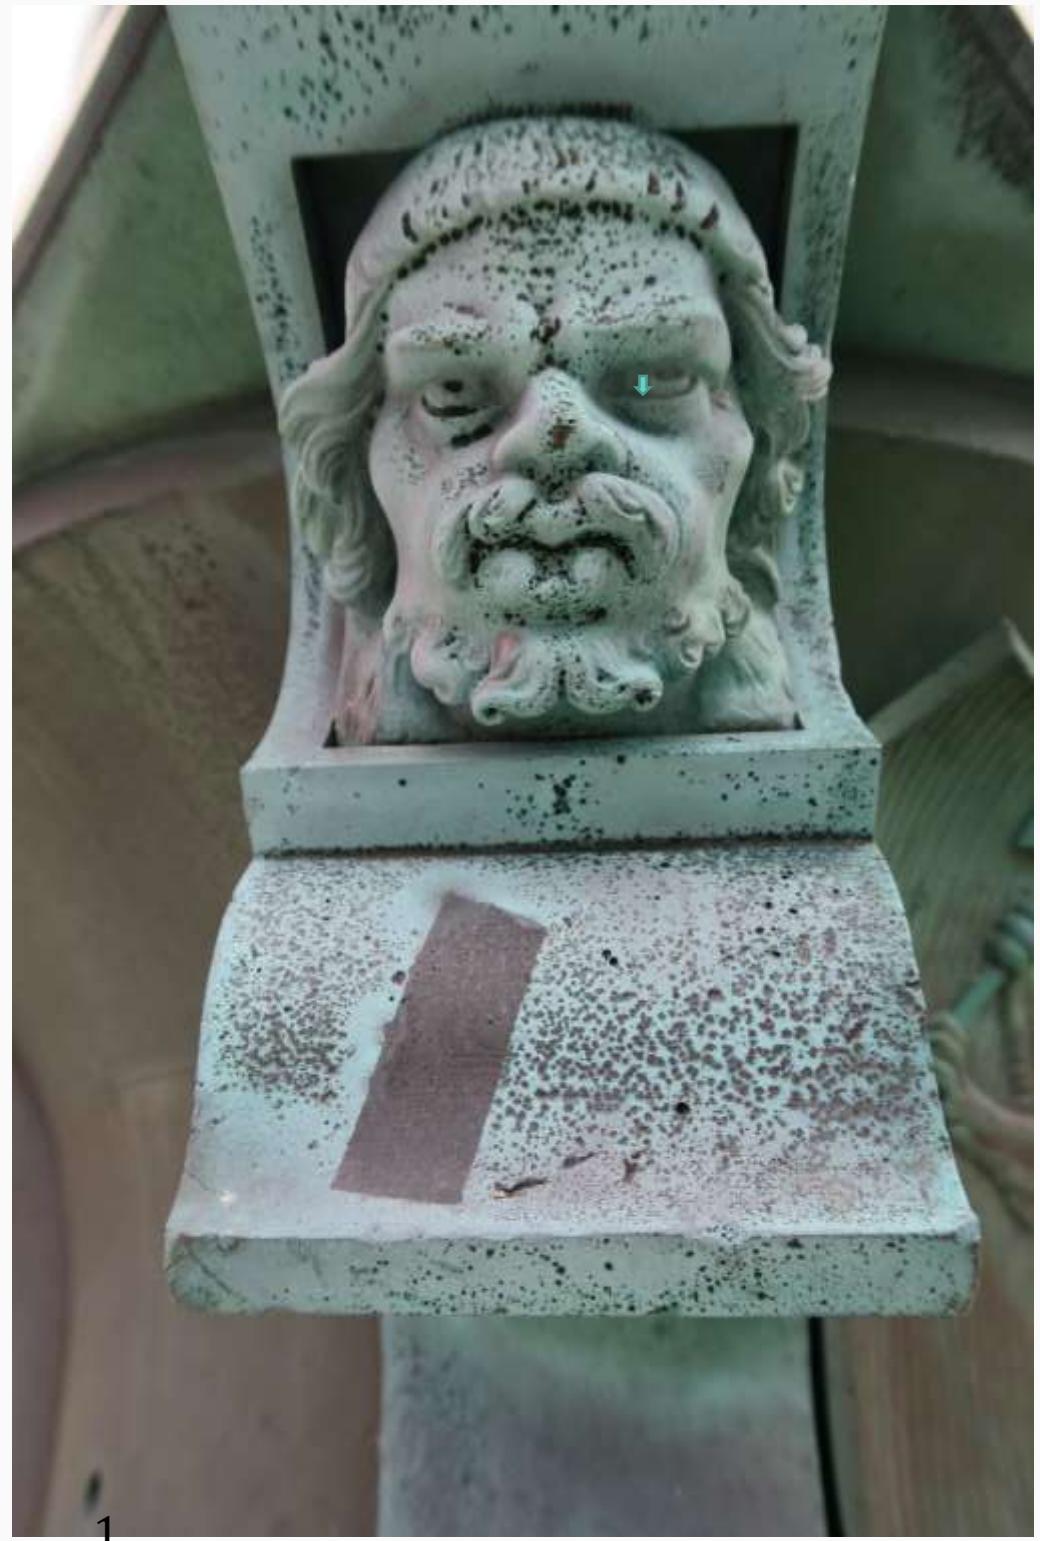
1

1. Corrosion
2. Bolts are missing
3. Tagging
4. Tight drainage channel

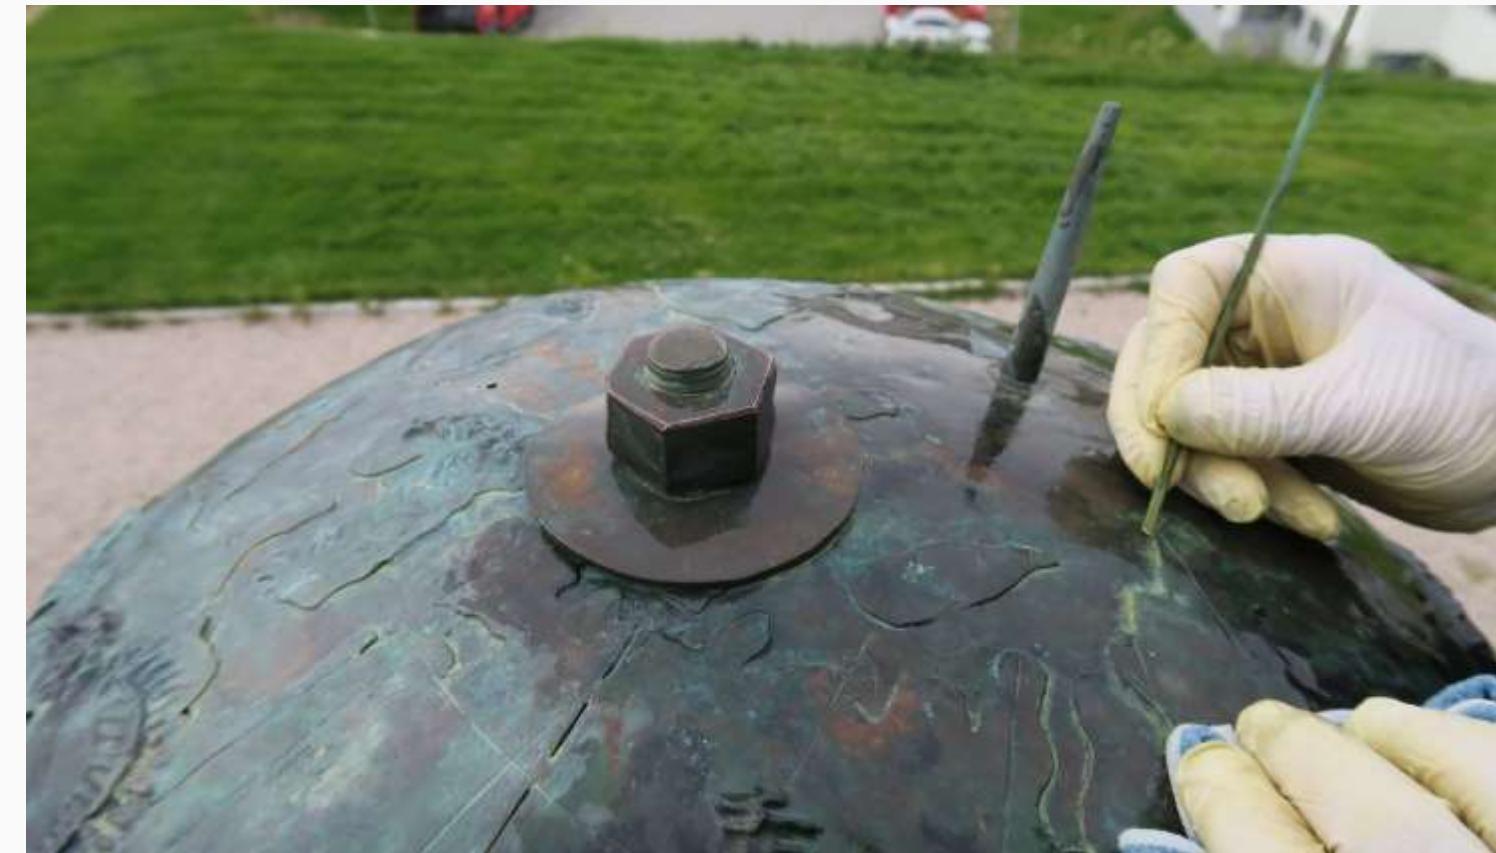
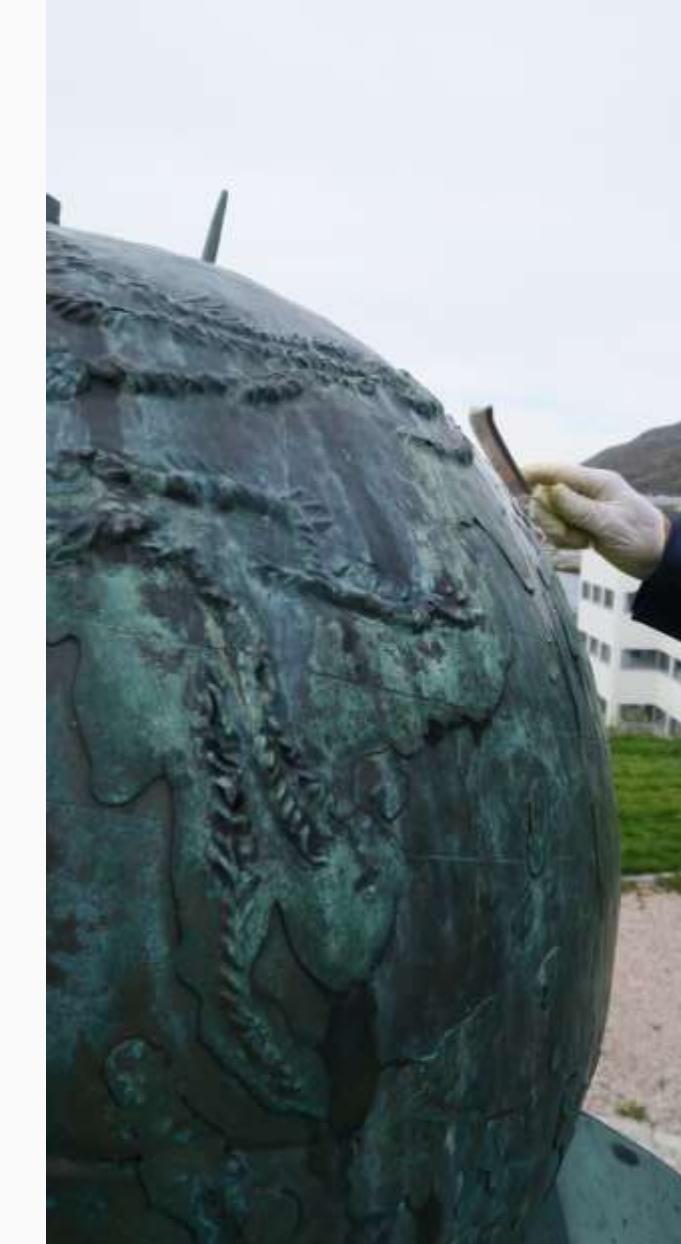
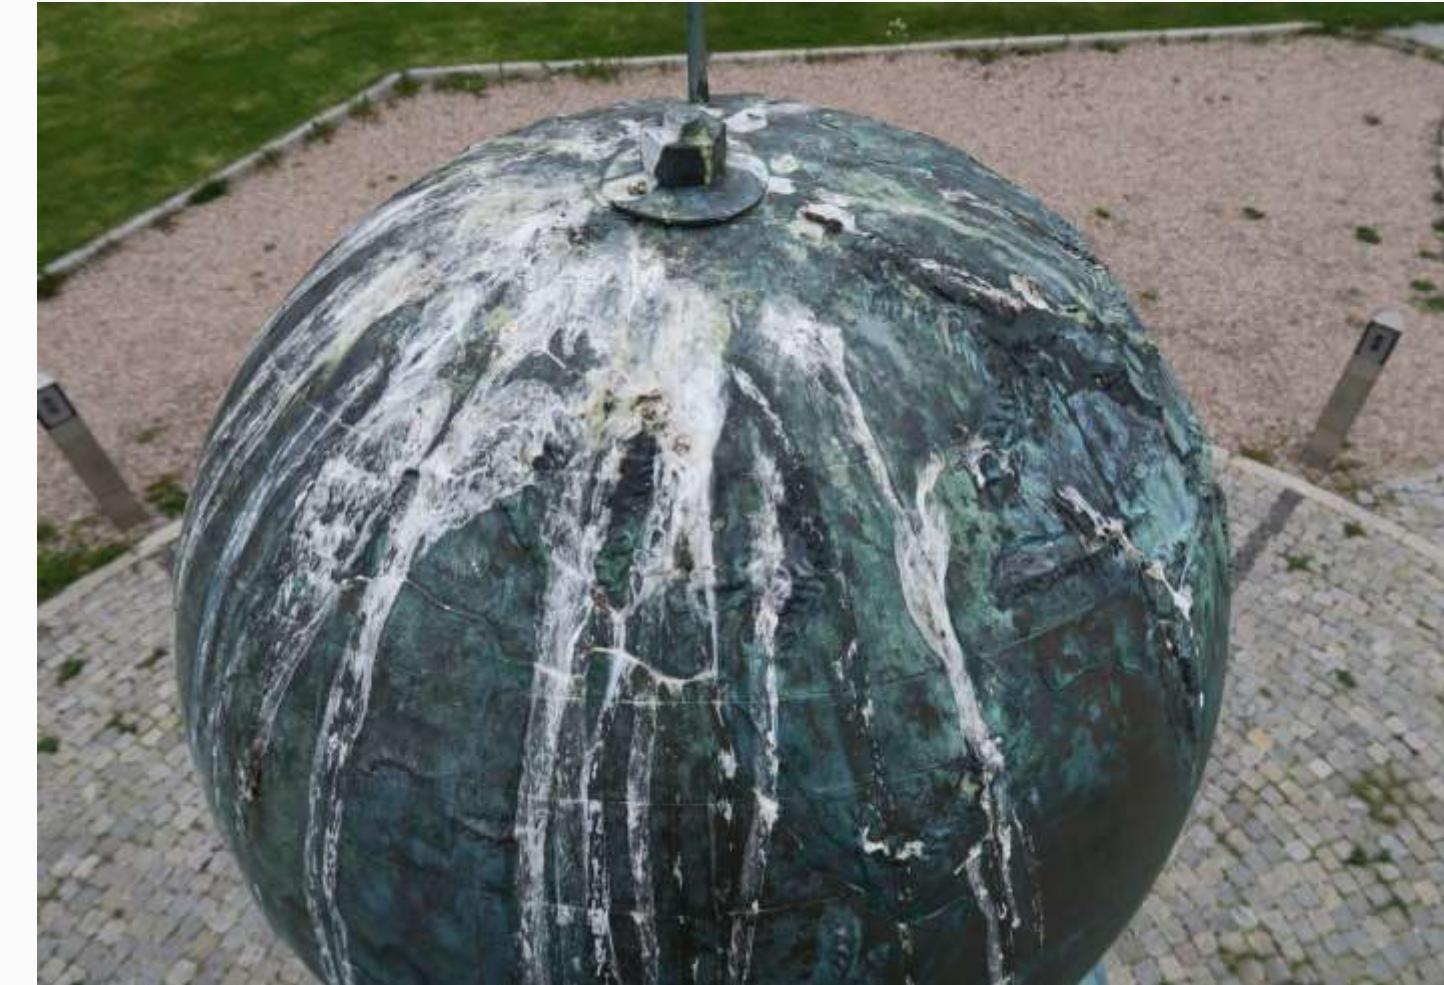
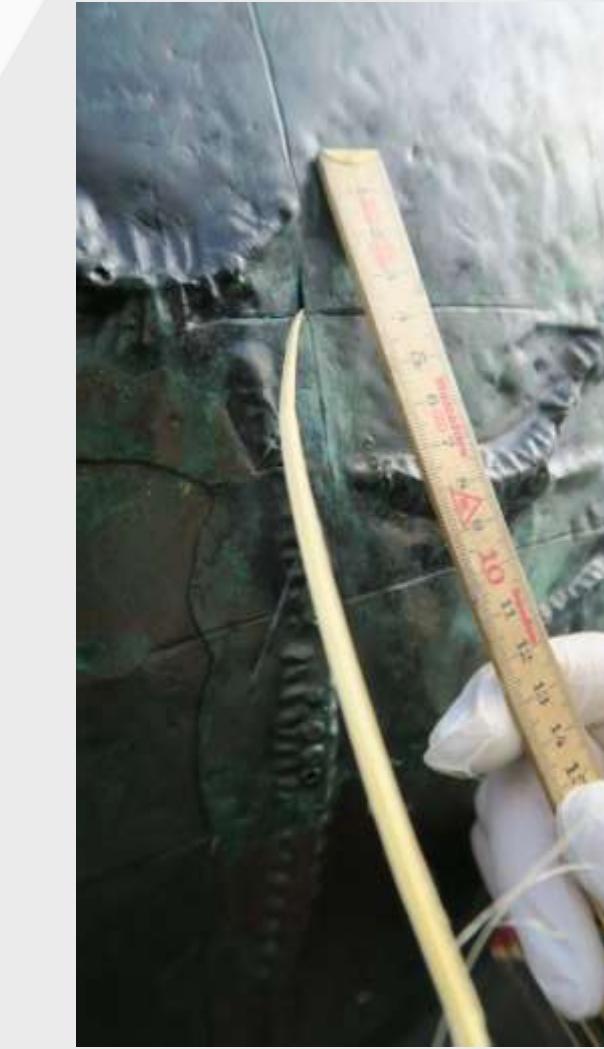
Copper is exposed to oxidation, heavy metal, birds excrement, salts and ammonia.
It is coated with verdigris.
Has a lot of small holes.
The first conservation of the globe and the capital happened in 1948-49 by NGO who also payed most of the expenses.
The second was by the local authorities in 2005.
The globe was in a bad condition and the continents stood and fought the wind as if they were to loosen from the surface of the earth
