To preserve the end point: The Meridian Statue

Gerd Johanne Valen. Site Manager Struve Geodetic Arc - Norway

Action plan and the WH Status.

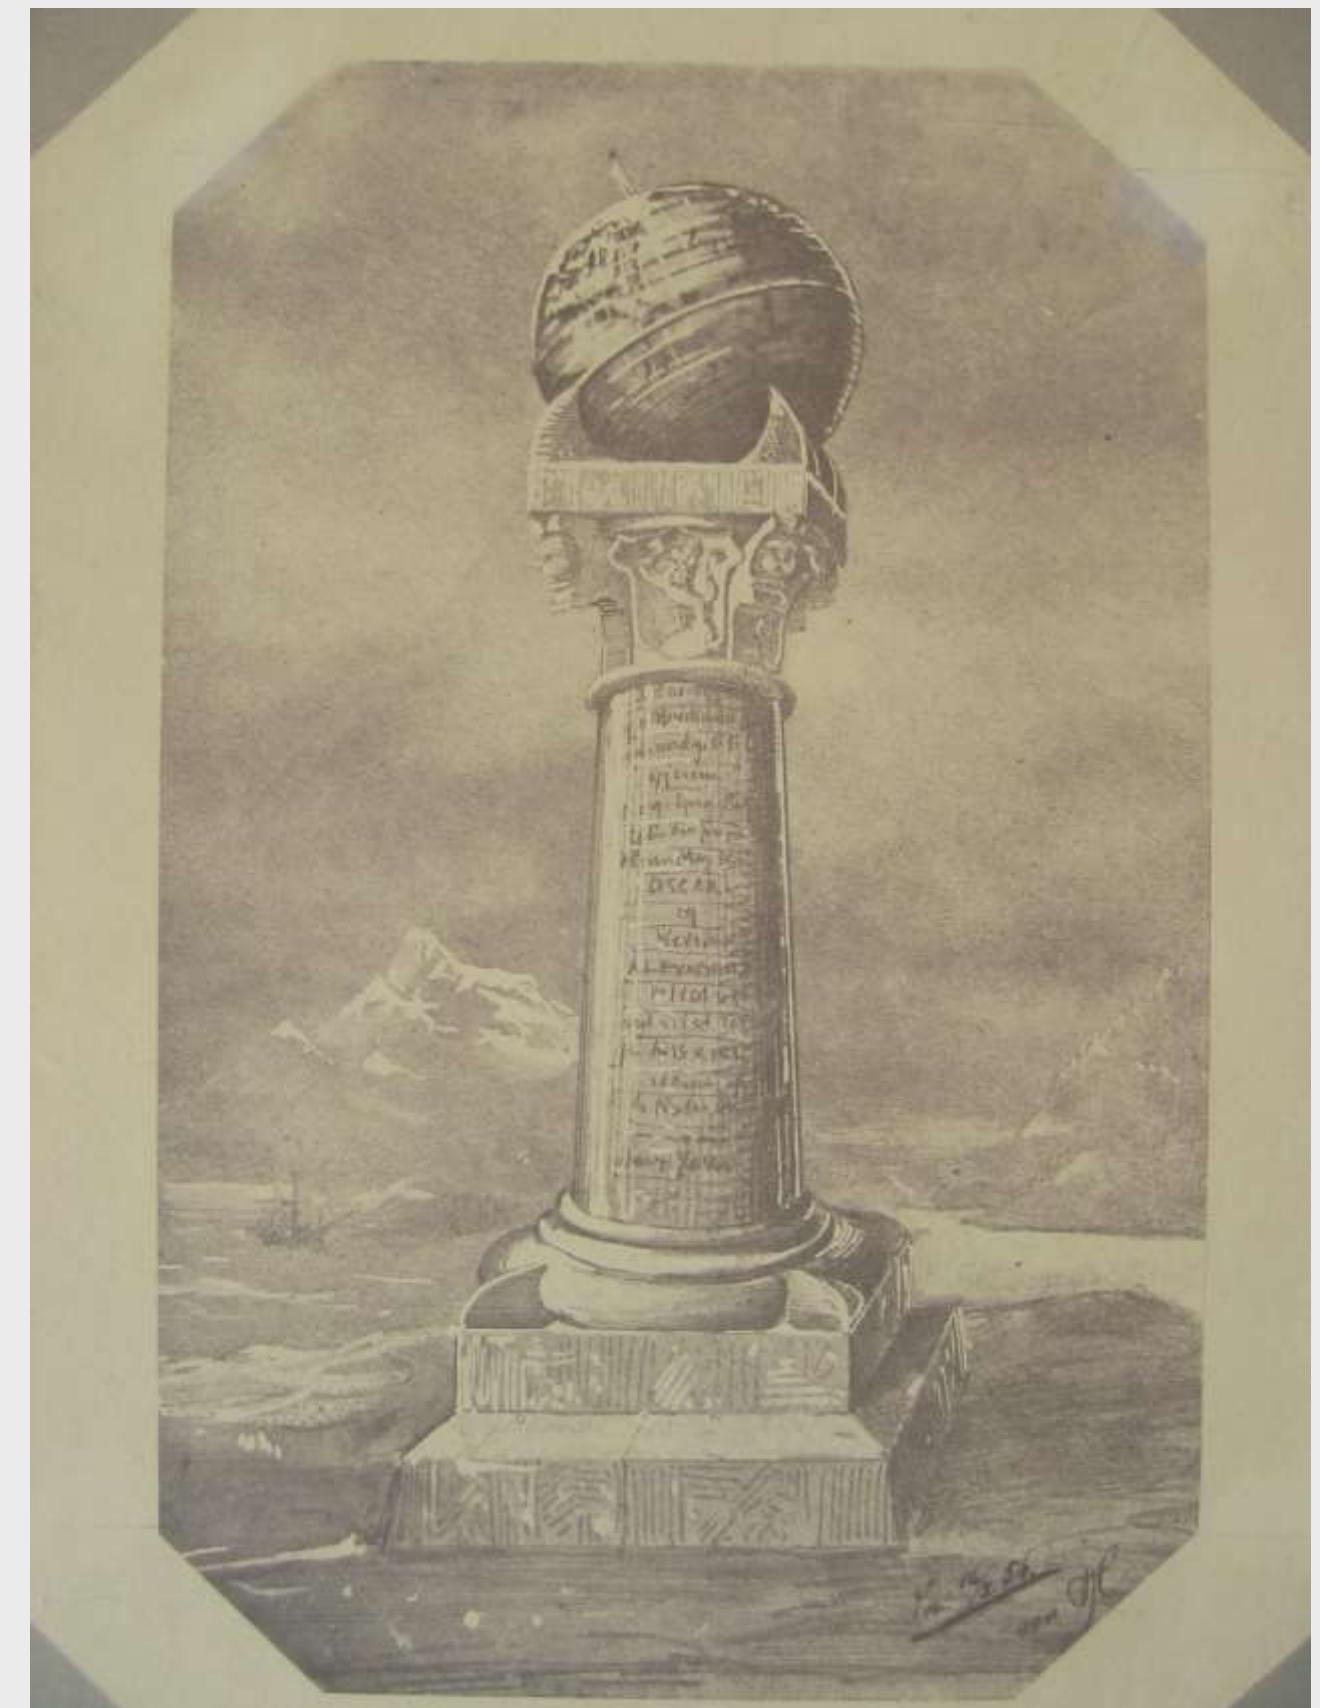
The Construction parts

The rock is extremely durable. But still it is effected by wind, rain and probably frost. From the North-West the weather condition is harsh. The engraved text must regular be renewed.

The construction or the method of joining the column with the capital is unknown. And there are tree weak points in the joints between the capital and the column. We do not know why.
